Manhole Inspection Summary

Manhole # S07MM1016MH

Insp Date: **5/31/07 10:29 AM**

Location Address: **3500 OAKMONT AVE**

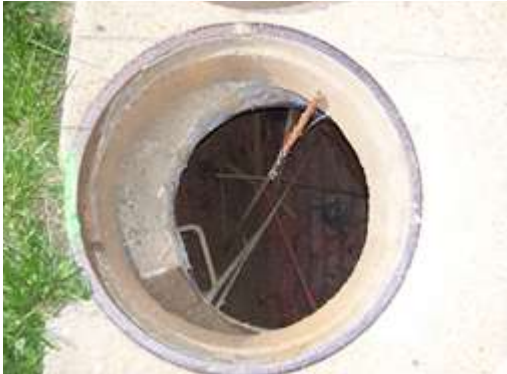
Top View

Condition: ☐ Sound ☐ Cracked ☐ Root Intrusion ☐ Deteriorated ☐ Leaks ☒ **Debris**

DEBRIS

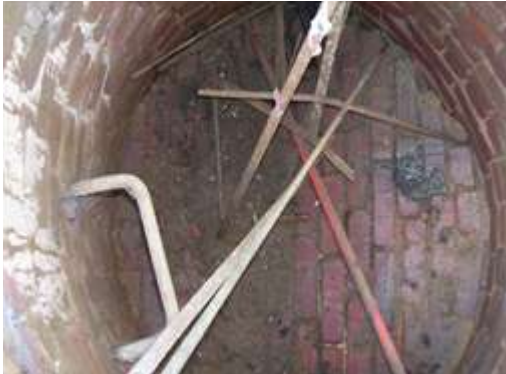
Defect 1

DEBRIS

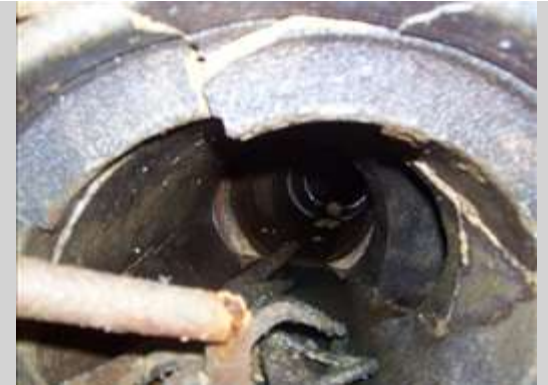
12 O'Clock Outflow

PIPE IS CRUSHED AND MANHOLE
(TERMINAL) HAS METAL RODS IN IT

Infiltration: **None** Pipe Seal Cond: **Broken**
